**Flood Control Project Maintenance  
Levee Inspections**

**Fall 2009 Levee Maintenance Deficiency Summary Report**

**Reclamation District No. 1500 Sutter Basin**

**Levee Inspection Report By Mile - Fall 2009**

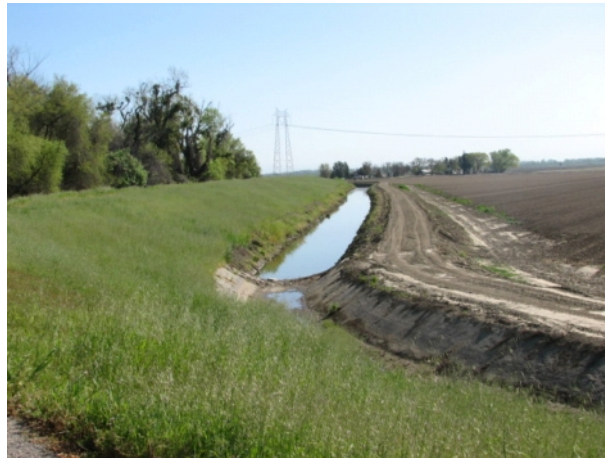
john\_gw\_20090924\_14.jpg

Levee Mile Report Line	9
Start Levee Mile	2.57
End Levee Mile	3.83
Location	Land Side
Category	Earthen Levee
Item	Encroachments

ag. ditch

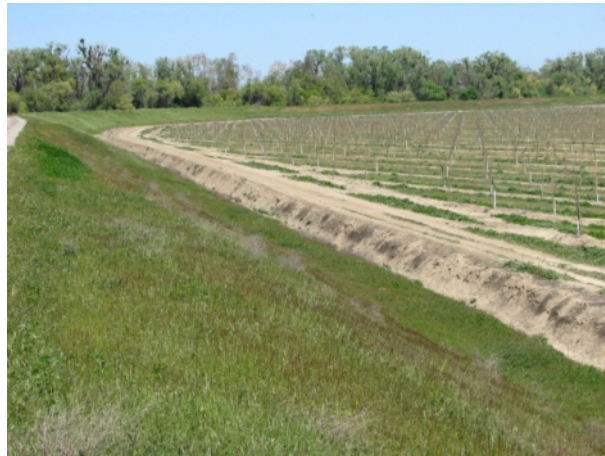
john\_gw\_20090924\_16.jpg

Levee Mile Report Line	44
Start Levee Mile	14.86
End Levee Mile	15.93
Location	Land Side
Category	Earthen Levee
Item	Encroachments

ag. ditch

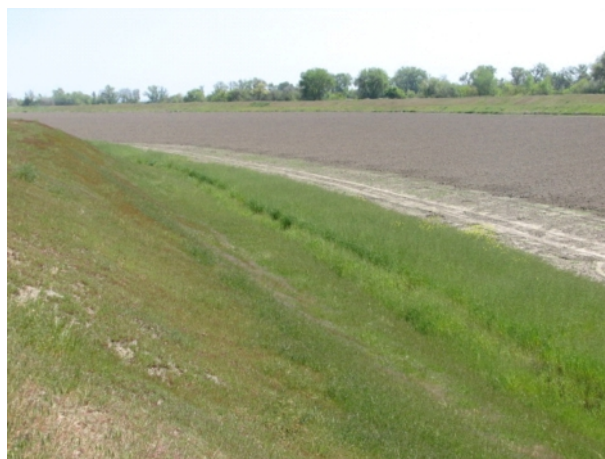
john\_gw\_20090924\_17.jpg

49	16.86	17.45	Earthen Levee	Encroachments	LS	PO	Agricultural Ditch	38.881092 ° -121.813713 °	38.887335 ° -121.808187 °	972 Y
50	17.83	17.83	Earthen Levee	Encroachments	LS	M	Prunings	38.891944 ° -121.804794 °	38.891944 ° -121.804794 °	994
51	18.51	18.51	Earthen Levee	Erosion / Bank Caving	WS	M	Note and monitor erosion site.	38.901140 ° -121.802750 °	38.901140 ° -121.802750 °	51
52	19.19	19.19	Earthen Levee	Encroachments	LS	PO	Buildings	38.901570 ° -121.791235 °	38.901570 ° -121.791235 °	36
53	19.22	19.22	Earthen Levee	Encroachments	LS	PO	Landscaping	38.901942 ° -121.790937 °	38.901942 ° -121.790937 °	37

Levee Mile Report Line	49
Start Levee Mile	16.86
End Levee Mile	17.45
Location	Land Side
Category	Earthen Levee
Item	Encroachments

ag. ditch

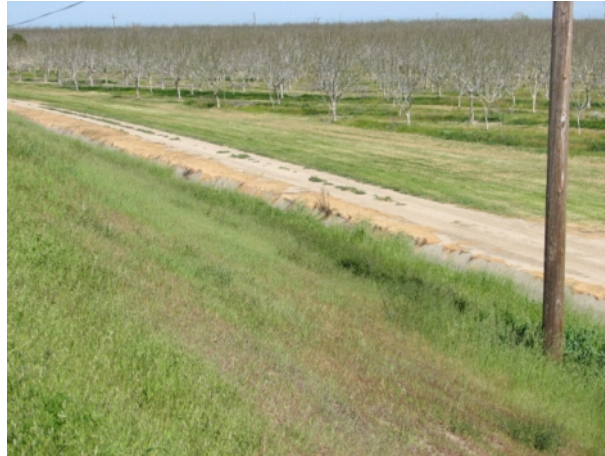
Levee Mile Report Line	55
Start Levee Mile	20.86
End Levee Mile	21.40
Location	Land Side
Category	Earthen Levee
Item	Encroachments
ag. ditch	
john_gw_20090924_18.jpg

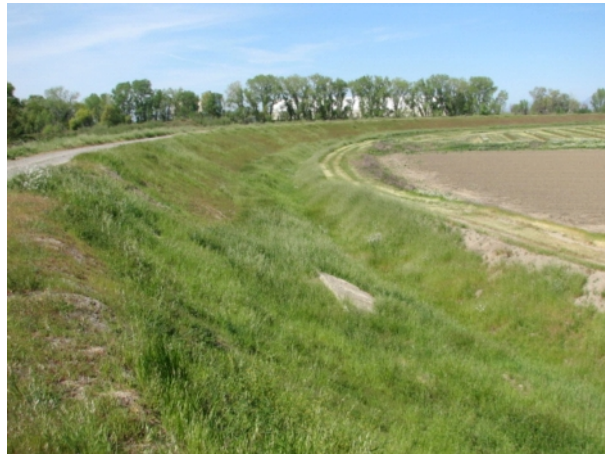
Levee Mile Report Line	58
Start Levee Mile	24.44
End Levee Mile	24.78
Location	Land Side
Category	Earthen Levee
Item	Encroachments
ag. ditch	
john_gw_20090924_19.jpg

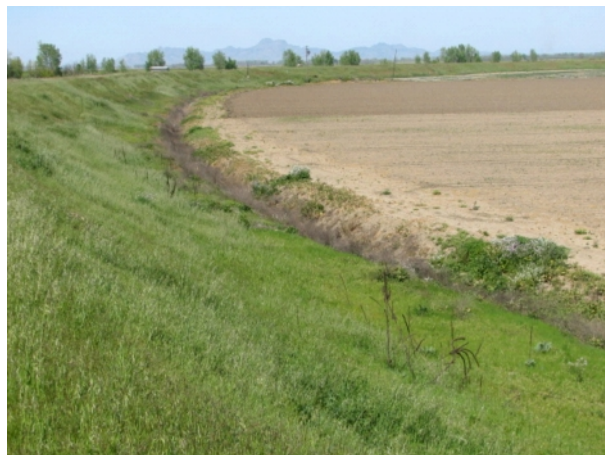
60	24.64	24.64	Earthen Levee	Encroachments	LS	M	Prunings	38.938957 ° -121.829282 °	38.938957 ° -121.829282 °	980
61	25.76	26.54	Earthen Levee	Encroachments	LS	PO	Agricultural Ditch	38.952500 ° -121.837247 °	38.961135 ° -121.830902 °	981 Y
62	26.84	27.07	Earthen Levee	Encroachments	LS	PO	Agricultural Ditch	38.964850 ° -121.833595 °	38.968083 ° -121.833593 °	982 Y
63	27.63	27.78	Earthen Levee	Encroachments	LS	PO	Agricultural Ditch	38.972440 ° -121.825892 °	38.972848 ° -121.823098 °	983 Y
64	28.12	29.60	Earthen Levee	Encroachments	LS	PO	Agricultural Ditch	38.976513 ° -121.819652 °	38.988433 ° -121.806403 °	984
65	28.73	28.73	Earthen Levee	Animal Control	LS	M	Exterminate rodents and backfill and compact or grout burrows.	38.985241 ° -121.819831 °	38.985241 ° -121.819831 °	996
66	30.60	30.60	Earthen Levee	Encroachments	LS	PO	Landscaping	38.996980 ° -121.794723 °	38.996980 ° -121.794723 °	45
67	31.34	31.81	Supplemental	USACE Erosion Survey	WS	U	Inspector Comments: beaver holes, tension cracks, slumping; wide berm area all along over 30' wide	39.006221 ° -121.812458 °	39.003293 ° -121.805031 °	957

Levee Mile Report Line	61
Start Levee Mile	25.76
End Levee Mile	26.54
Location	Land Side
Category	Earthen Levee
Item	Encroachments
ag. ditch	
john_gw_20090924_20.jpg

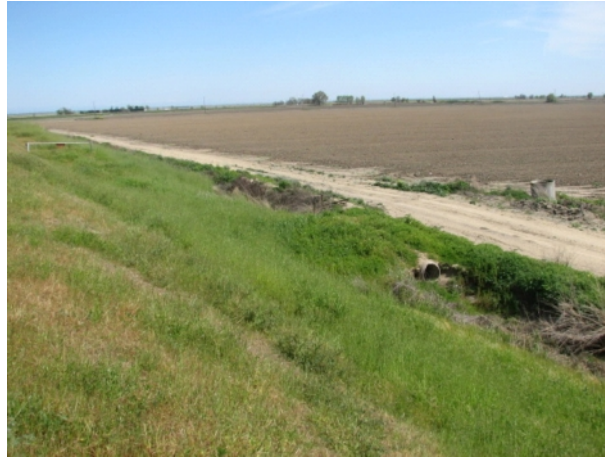
Levee Mile Report Line	62
Start Levee Mile	26.84
End Levee Mile	27.07
Location	Land Side
Category	Earthen Levee
Item	Encroachments
ag. ditch	
johngw_20090924_21.jpg

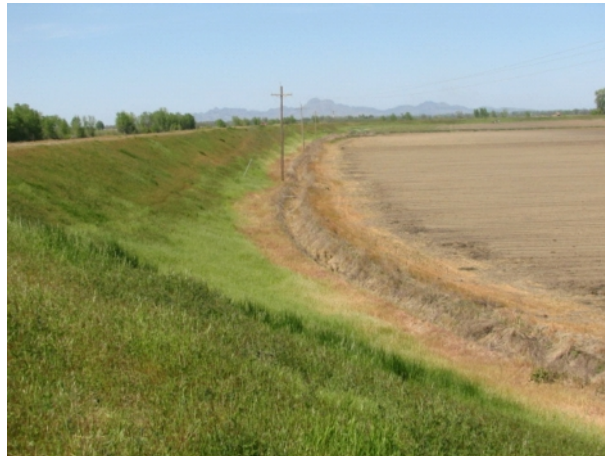
Levee Mile Report Line	63
Start Levee Mile	27.63
End Levee Mile	27.78
Location	Land Side
Category	Earthen Levee
Item	Encroachments
ag. ditch	
johngw_20090924_22.jpg

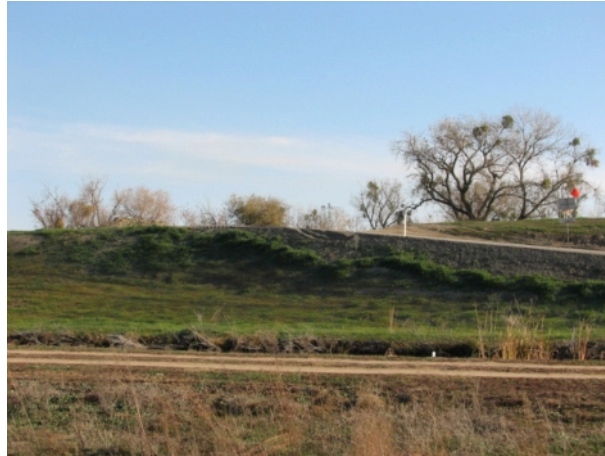
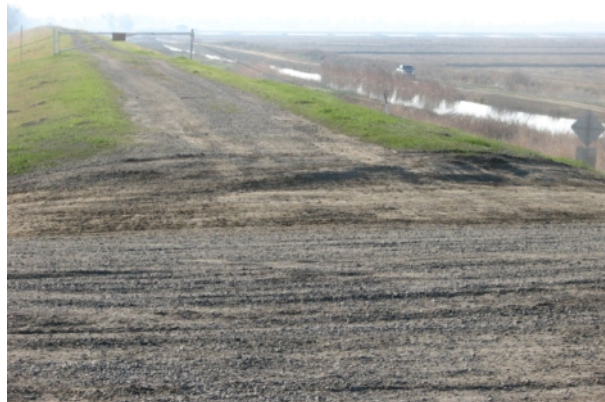
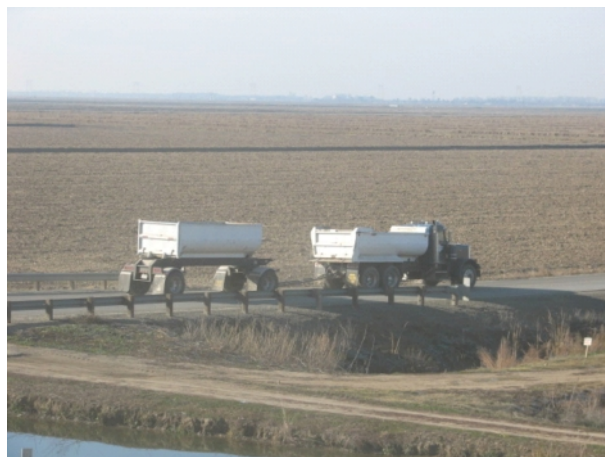
6	11.03	11.03	Earthen Levee	Crown Surface / Depressions / Rutting	CR	M	Add appropriate gravel or road base. Grade and compact. Inspector Comments: This is a county (Kirkville Rd) that crosses the levee. Over time with truck traffic and the county grading the road has degraded the crown. Need to have AB material to reestablish the crown to proper grade.	38.909385 ° -121.639435 °	38.909385 ° -121.639435 °	17 Y

Levee Mile Report Line	6
Start Levee Mile	11.03
End Levee Mile	11.03
Location	Crown
Category	Earthen Levee
Item	Crown Surface / Depressions / Rutting
cross view of levee crown	
johngw_f_20091209_090.jpg

Levee Mile Report Line	6
Start Levee Mile	11.03
End Levee Mile	11.03
Location	Crown
Category	Earthen Levee
Item	Crown Surface / Depressions / Rutting
dip coming off the crow of levee	
johngw_f_20091209_091.jpg

Levee Mile Report Line	6
Start Levee Mile	11.03
End Levee Mile	11.03
Location	Crown
Category	Earthen Levee
Item	Crown Surface / Depressions / Rutting
typical truck that crosses the levee	
johngw_f_20091209_092.jpg
